M3 UAX Steering Linkage Service Notice:

M-3 UAX steering rod service issue

date: 2008/09/19

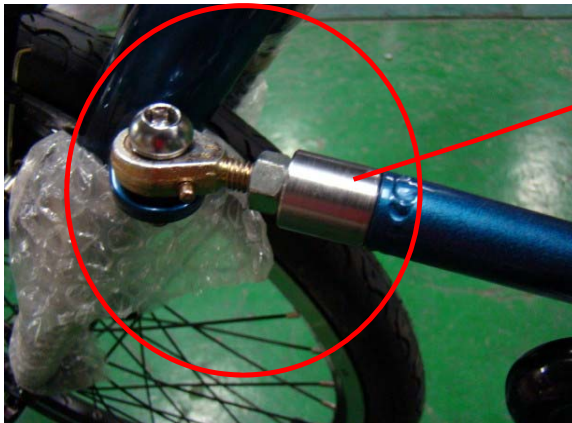
Due to an error at the factory, the steering linkage was made too short. In order to correct the problem attach the 20mm extension to the front end of the rod.

Steering rod extension.

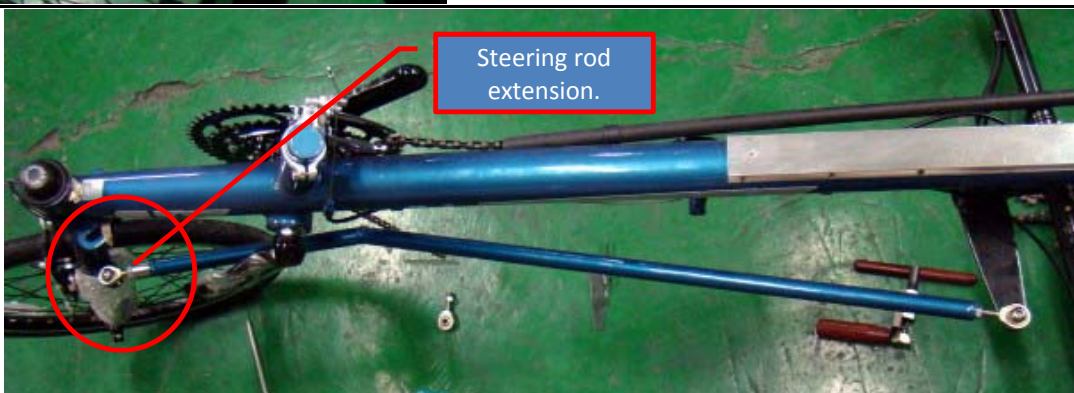
Steering rod extension.
