date: 2008/07/10

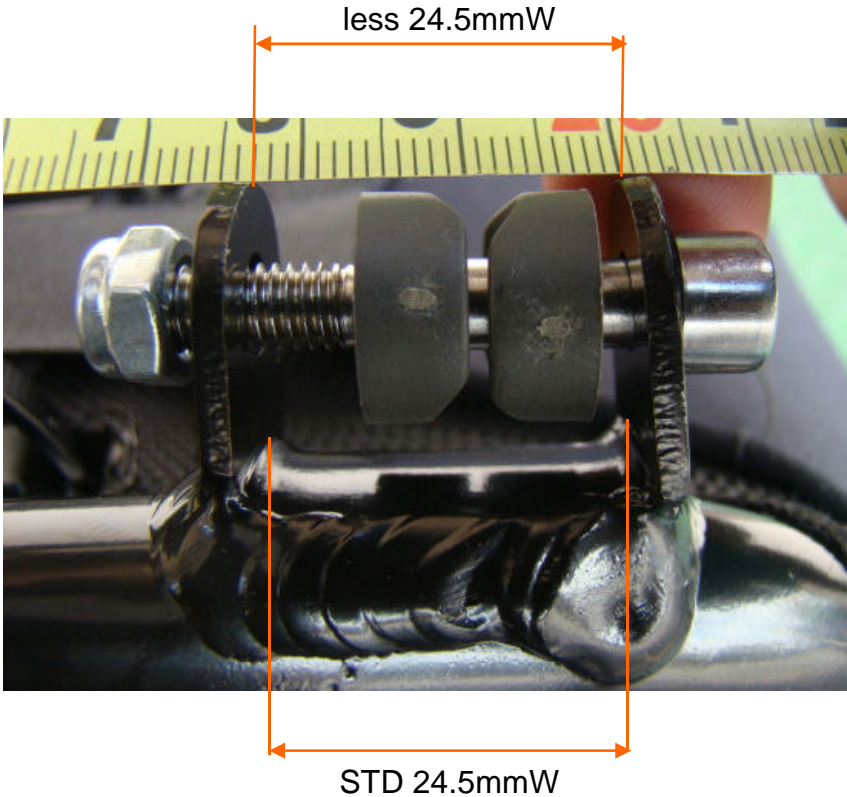
Some Upper strut brackets on ALLOY seat backs were bent in the manufacturing process and are less than 24.5mm causing some strut assembling difficultly.
