M3 UAX Cassette Service Notice:

M-3 UAX Cassette service issue

date: 2008/09/19

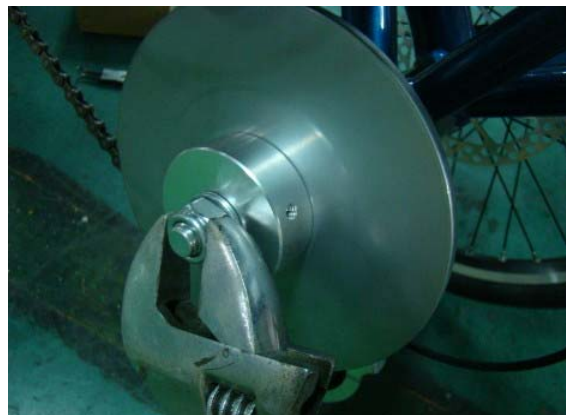
step 1.

Remove the Nylock Nut and Washer.

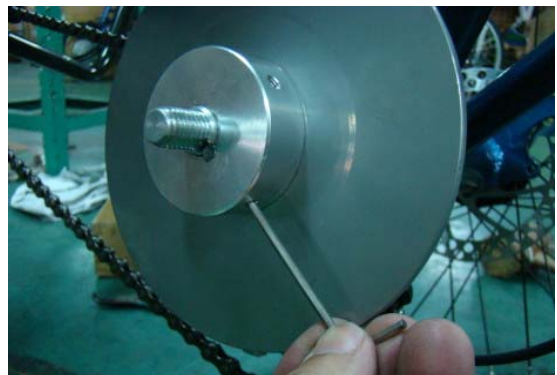
step 2.

Loosen the 2 set screws.

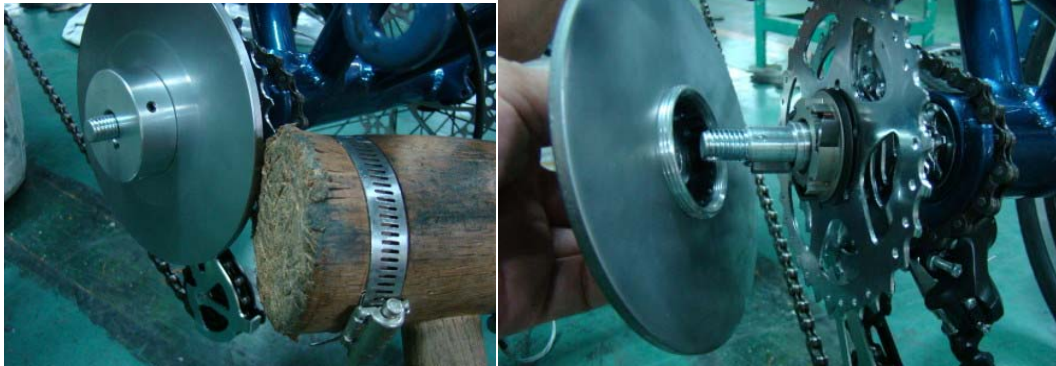
step 3.

Slide off the Lock Base. Penetrating oil and/or Gentle mallet hits may be required.

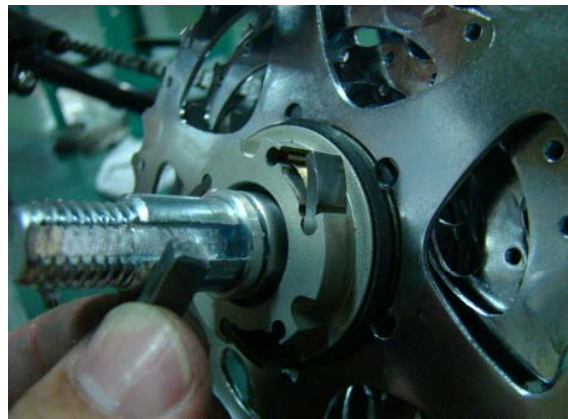
step 4.

Remove axle key.

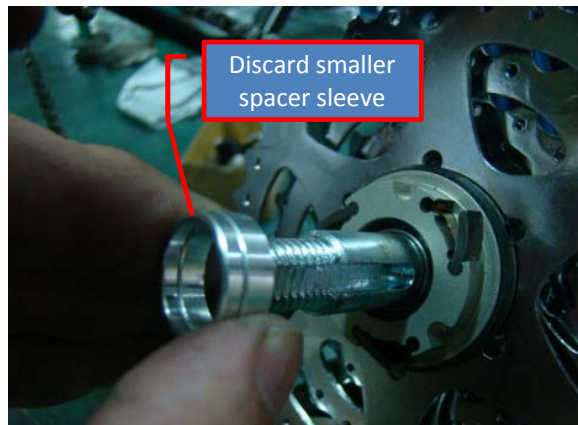
step 5.

Remove the 2 small Spacer Sleeves. Discard smaller spacer sleeve and re-install 4mm sleeve only

Due to an error in assembly at the factory, the freehub assembly has an extra 2mm spacer installed causing the cassette to pull away from the shell causing the pawls to become lodged in the gap. By removing the 2mm spacer (but leave the 4mm spacer) and the rubber seal, the correct tolerance will be achieved and the potential problem will be eliminated. Also the unit may not have been greased upon assembly, this can also be done while it is disassembled.

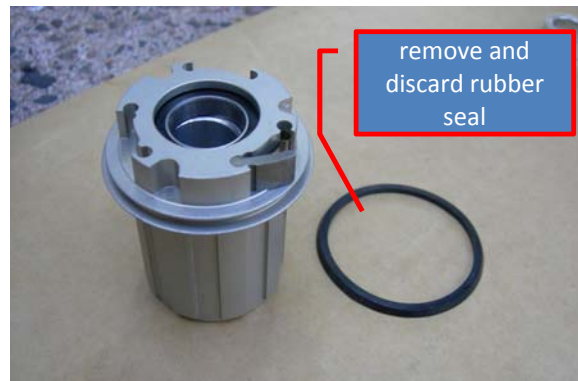
step 6.

Remove and discard freehub body seal.

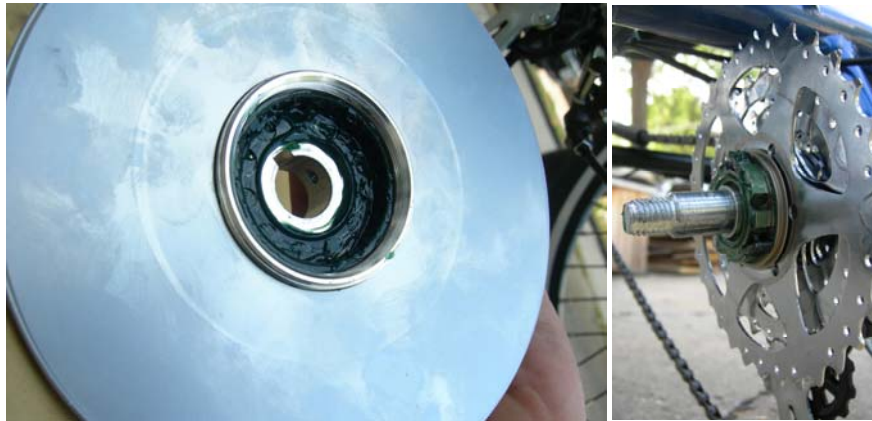
step 7.

Lubricate as shown.

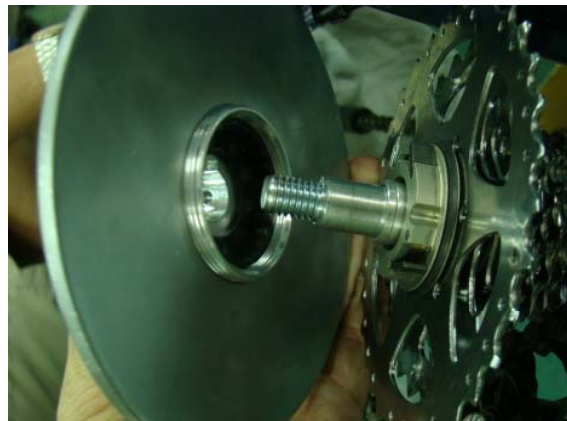
step 8.

Re-install the Lock Base carefully lining up the 3 pawls with the detents.

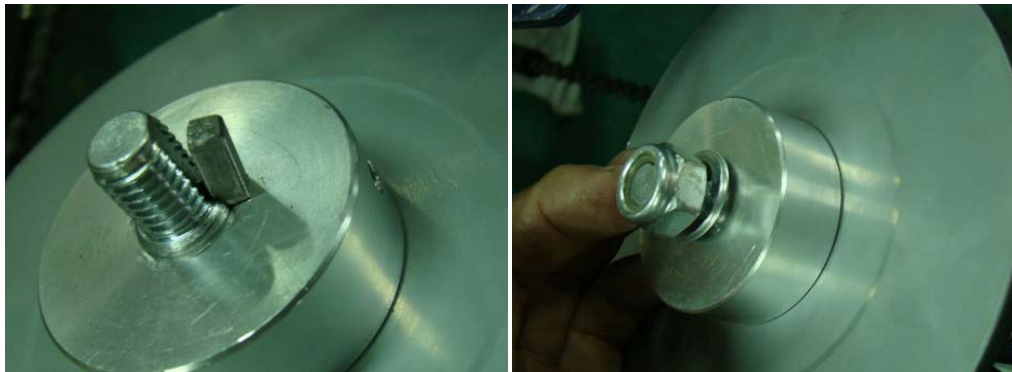
step 9.

Install Axle Key and Nylock Nut.
